State of Alaska Department of Fish and Game Habitat and Restoration Division

Nomination for Waters Important to Anadromous Fish

To: Phil Mooney (E-mail)
Subject: tawah lost river question

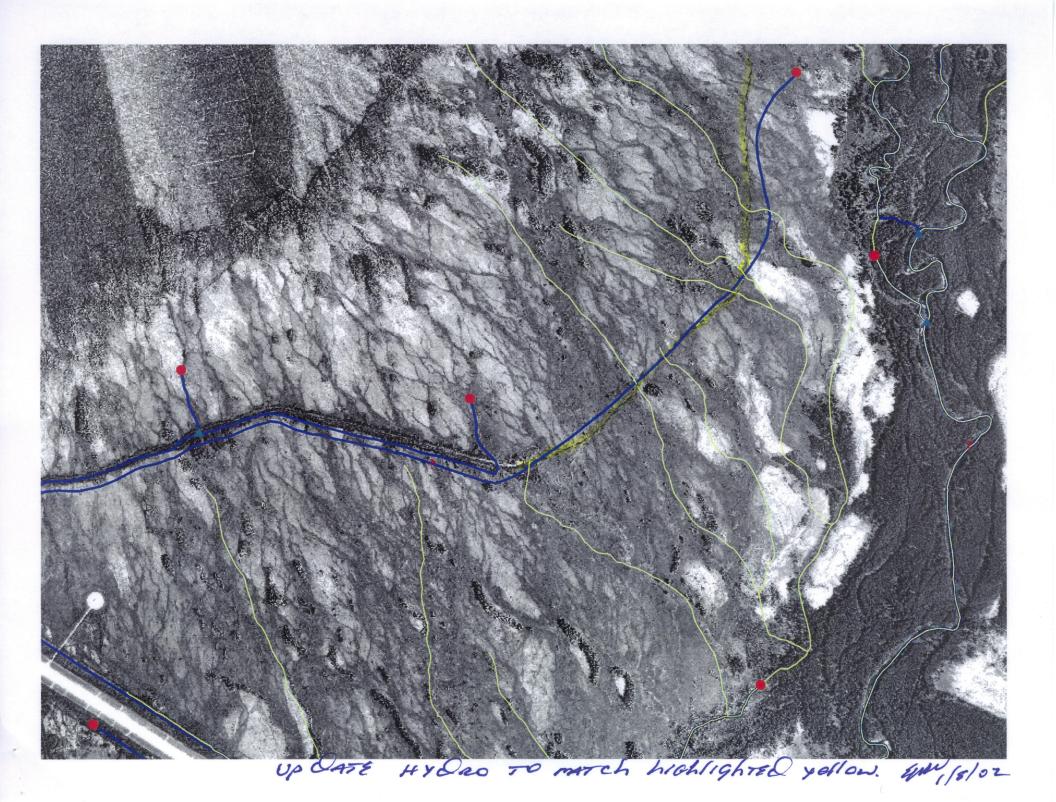
Phil this depicts the question I had with the stream along the south side of the road. As you can see the stream extends quite a ways to the NE while all the USFS hydro and the drainages on the photo flow NW to SE. From the photo it looks like there might be an ATV trail or something there but it doesn't seem right that it would be a stream channel cutting across all these other drainages. If you can show me where the upper end of this drainage should be or if I should cut it off at the end of the road. I also noticed that these don't quite line up with the road. I'm checking to see whats more correct the DRG or Orthophoto and will correct accordingly.

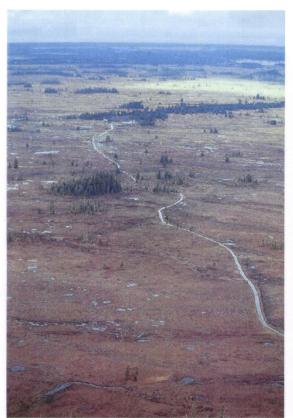
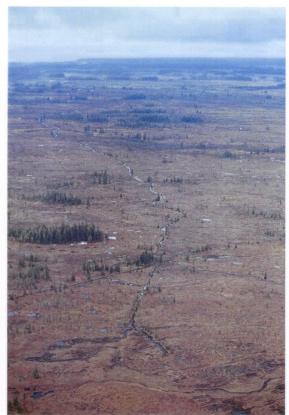
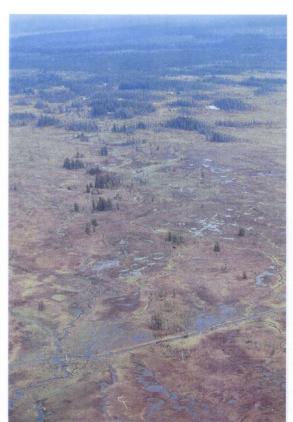
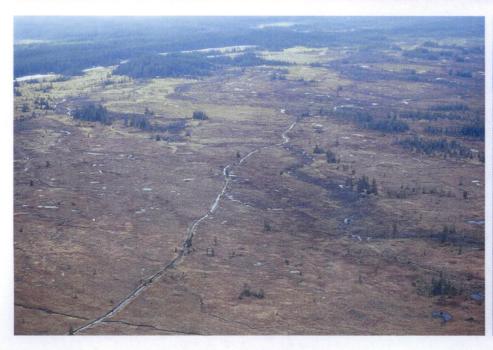
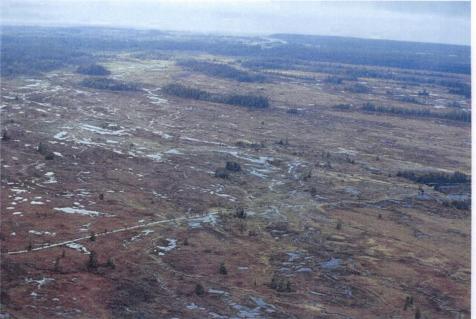
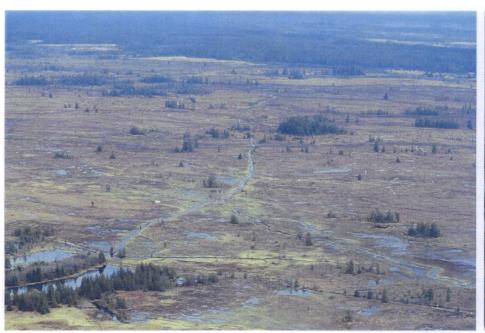
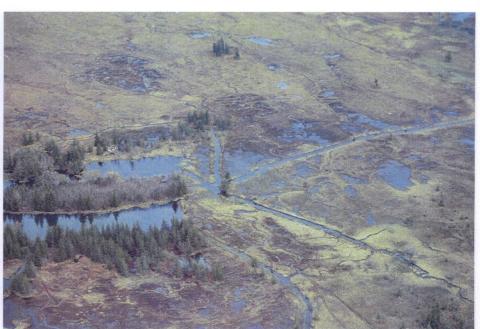
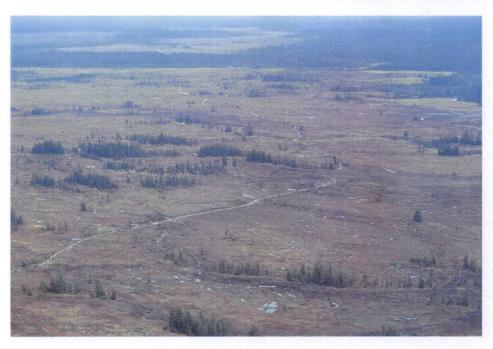
The stream is actually an old cat track trench road contructed to a well

site to the NE. You are correct that the topography has the streams flowing NW to SE. This old cut intercepted all of those drainages and is deep enough (more than 5 - 6' in places) that it intercepts a lot of flow and re-directs it along the south side of the Colorado Road. The beavers have dammed up many of the interception points. Because of the sheet flow nature of the Forelands, most of the streams start again on the south side and continue on their way to the SE. I've enclosed a series of photos that show the situation pretty well. Phil ----Original Message----
